# Manhole Inspection Summary

Manhole # S43II\_019MH

Insp Date: **4/24/08 10:51 AM**

**Location** Address: **Regester St**

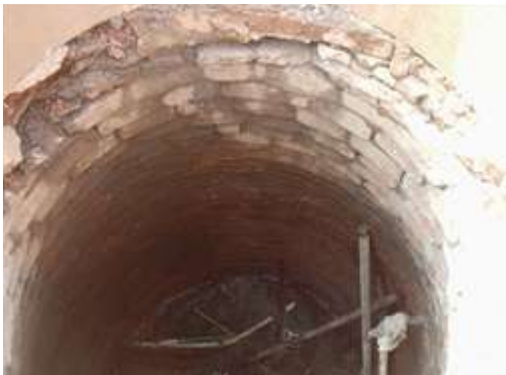
Defect 1

Condition: ☐ Sound ☐ Cracked ☐ Root Intrusion ☒ **Loose Brick** ☒ **Deteriorated**

Infiltration: ☐ None ☐ Joint ☐ Cracks ☒ **Mortar** ☐ Roots ☐ Wall

Deterioration

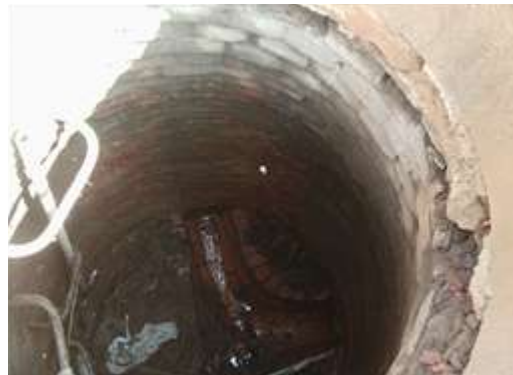
Defect 2

Loose Bricks

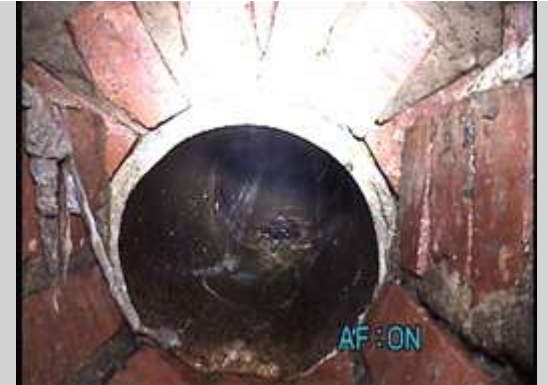
12 O'Clock Outflow

Pipe Height: **8.4** (in.) Rod and Bar (Angled)  
Pipe Material: **Clay** ☐ Pipe Lined  
Invert Depth: **9.50** (ft.) Flow Characteristics: **Fast**  
Deposits: ☒ None ☐ Mud ☐ Sludge ☐ Debris ☐ Grease  
Silt Depth: (in.) Deposits Extent:  
Infiltration: **None** Pipe Seal Cond: **Sound**

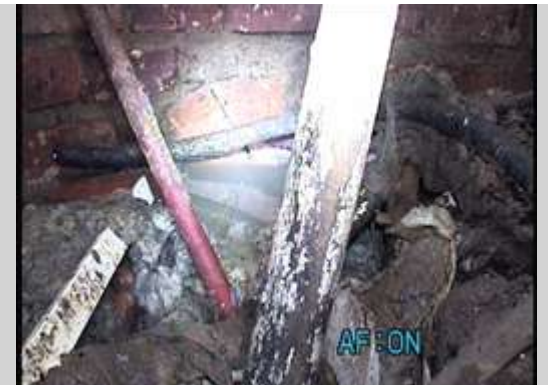
4 O'Clock Inflow

heavy debris at 4 o'clock pipe

Pipe Height: **8.4** (in.) Rod and Bar (Angled)  
Pipe Material: **Clay** ☐ Pipe Lined  
Invert Depth: **9.20** (ft.) Flow Characteristics: **None**  
Deposits: ☐ None ☐ Mud ☐ Sludge ☒ **Debris** ☐ Grease  
Silt Depth: **8** (in.) Deposits Extent: **Heavy**  
Infiltration: **None** Pipe Seal Cond: **Sound**

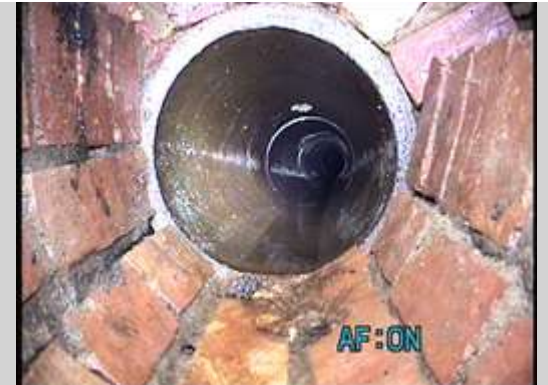
9 O'Clock Inflow

Pipe Height: **8.4** (in.) Rod and Bar (Angled)

Invert Depth: **8.90** (ft.) Flow Characteristics: **Fast**

Deposits: ☒ None ☐ Mud ☐ Sludge ☐ Debris ☐ Grease

Infiltration: **None** Pipe Seal Cond: **Sound**
